Creation Date / Fecha Creación	12/06/08	Author / Autor	Alberto Fernández García
Revision Date / Fecha Revisión		Revision / Revisión	Jose Rubio
Version / Versión	0	Approval / Aprobación	Jose Rubio
Subject / Título	MTBF 50/11 mechanism

The target of this test is to demonstrate the good performance of the whole life of two panels central opening doors and two panels side opening doors, with mechanism 50/11.

The method to demonstrate the test target has been the "Success-Run" method. The target will be verified if the **tests are running without any failure during 3 Millions of cycles.**

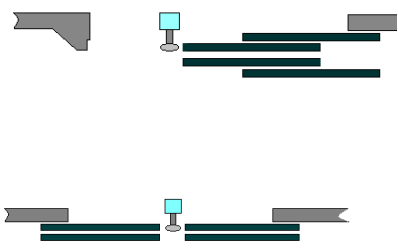
<p>Load case 1</p>	<p>Obstacle during closing procedure on hoistway door, 1500 mm from bottom. Position where velocity is greatest</p>

<p>Obstacle with rubber coating (approx. 30 mm thick), Obstacle fixed in position to be applied during 8'000²⁾ cycles</p>
<p>Load case 2</p>	<p>Obstacle during closing procedure, On hoistway door, Foot height at 150 mm Position where velocity is greatest</p>

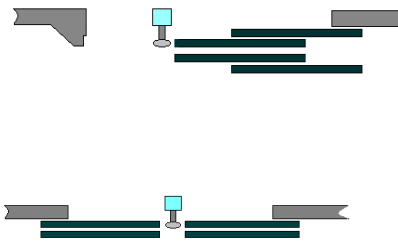
<p>Obstacle with rubber coating (approx. 30 mm thick), Obstacle fixed in position to be applied during 500³⁾ cycles.</p>

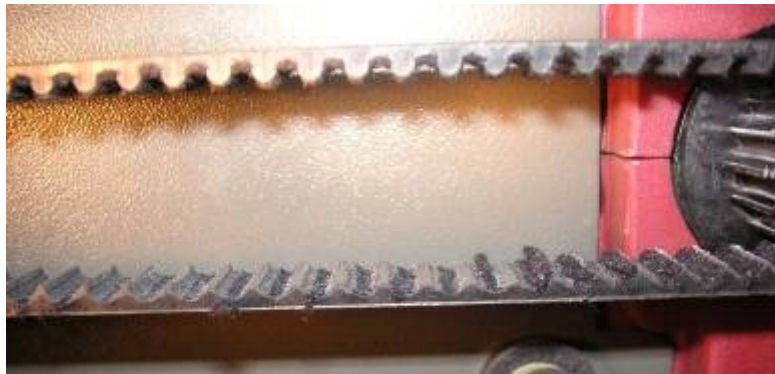
6.3 Belt

On conclusion, the belt suffers a normal waste after 3 Millions of cycles. It is reflected on the next image.
